Hunters Point Naval Shipyard BCT Meeting

Parcel B (Excluding IR Sites 7 & 18) Remedial Action Update

December 6, 2012

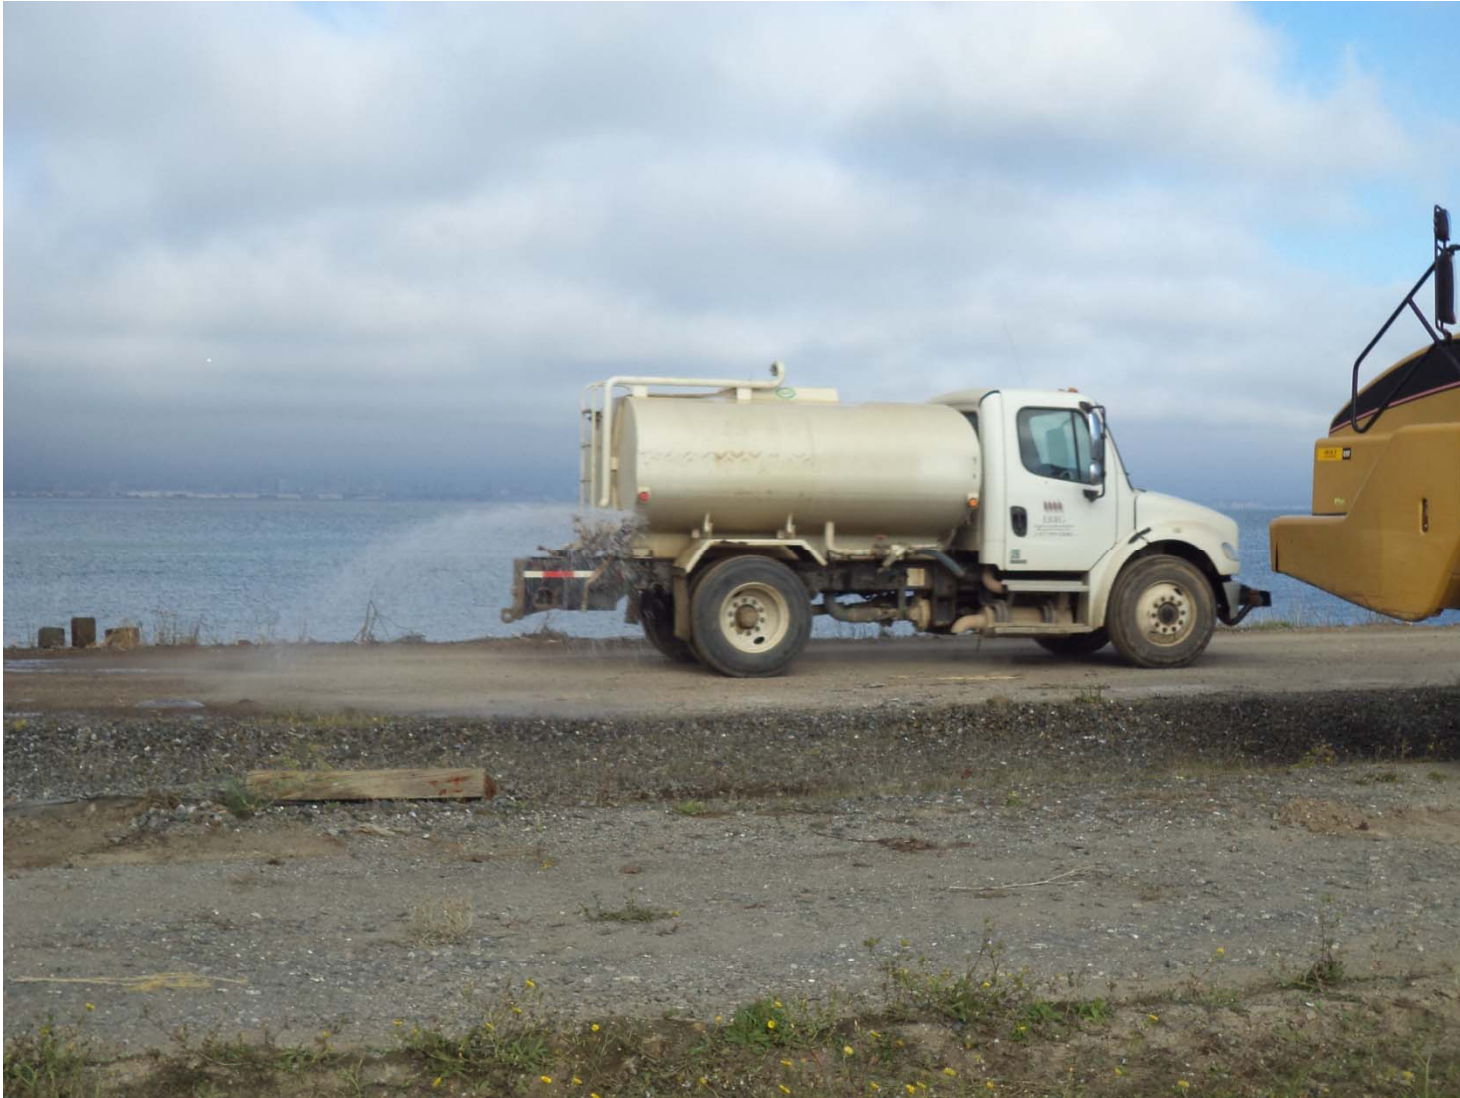
RA Photos Dust Control With Water Trucks

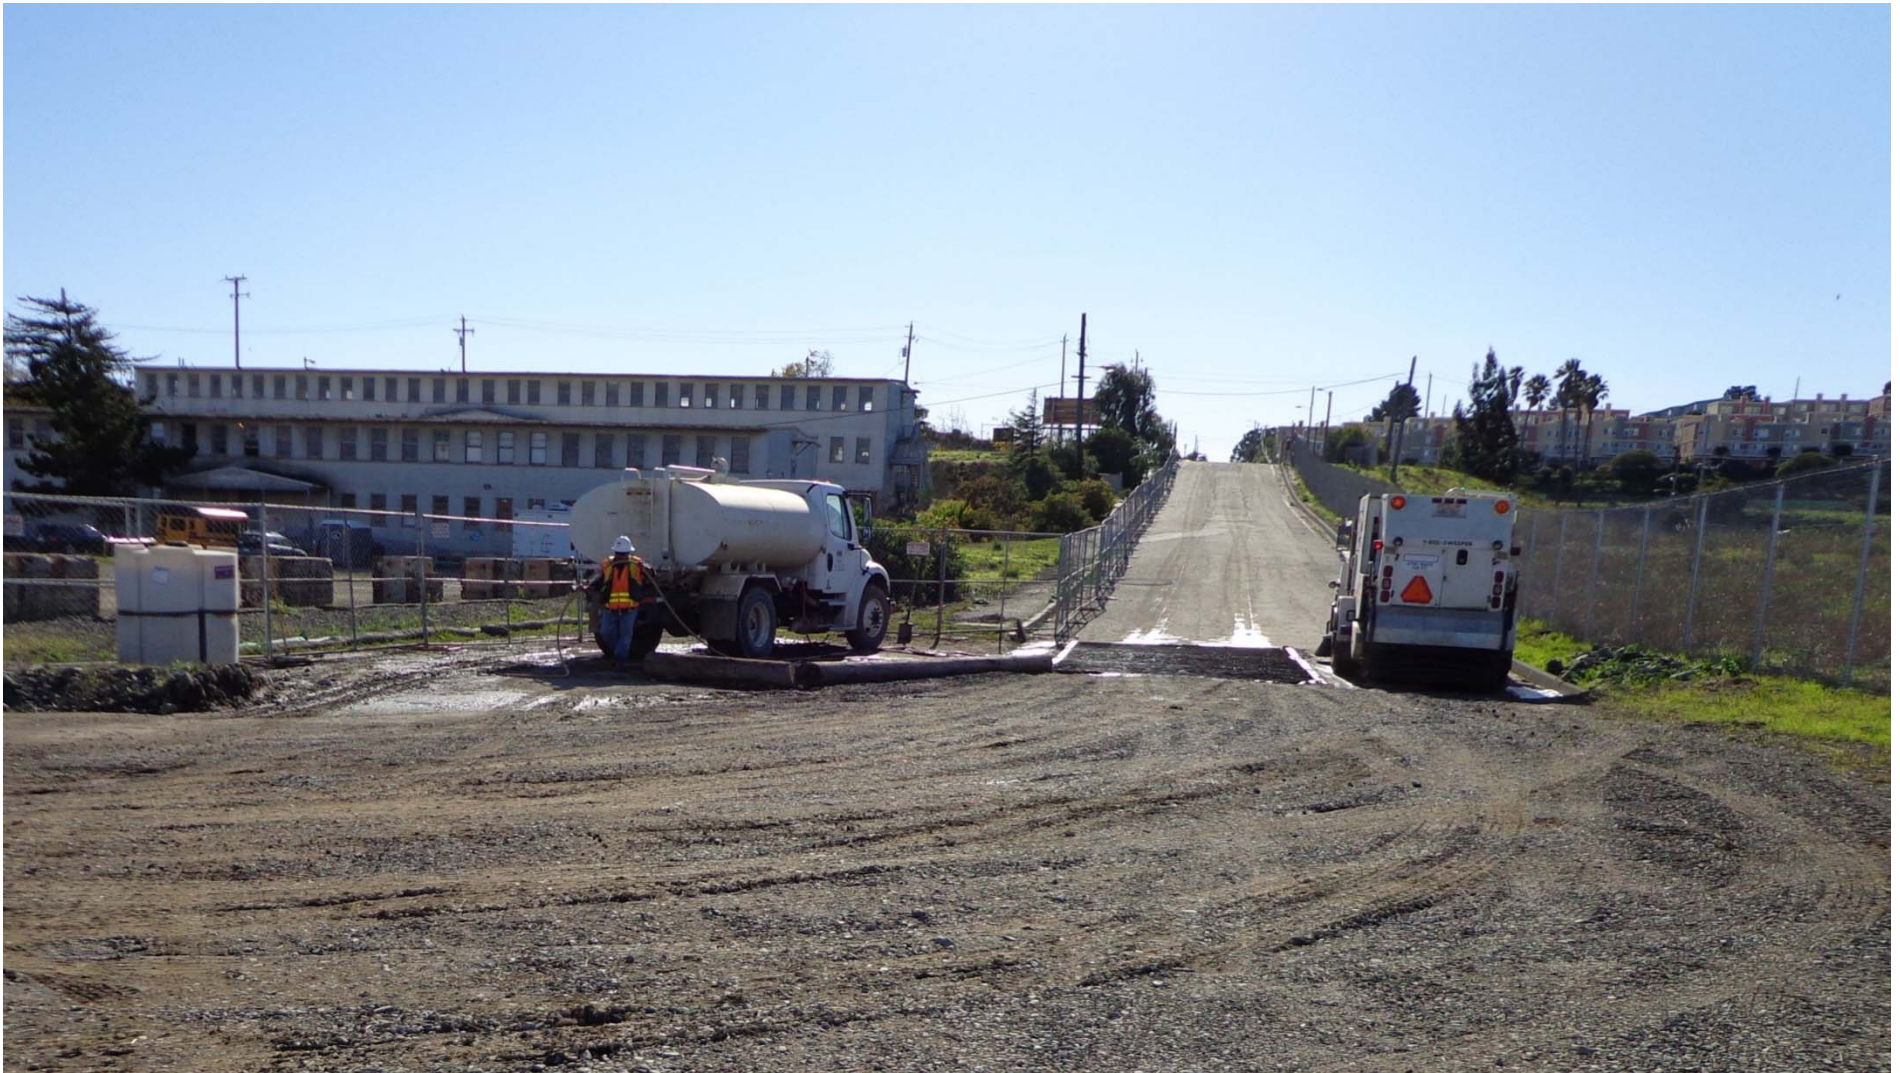
RA Photos Tire Wash and Street Sweeper in Operation

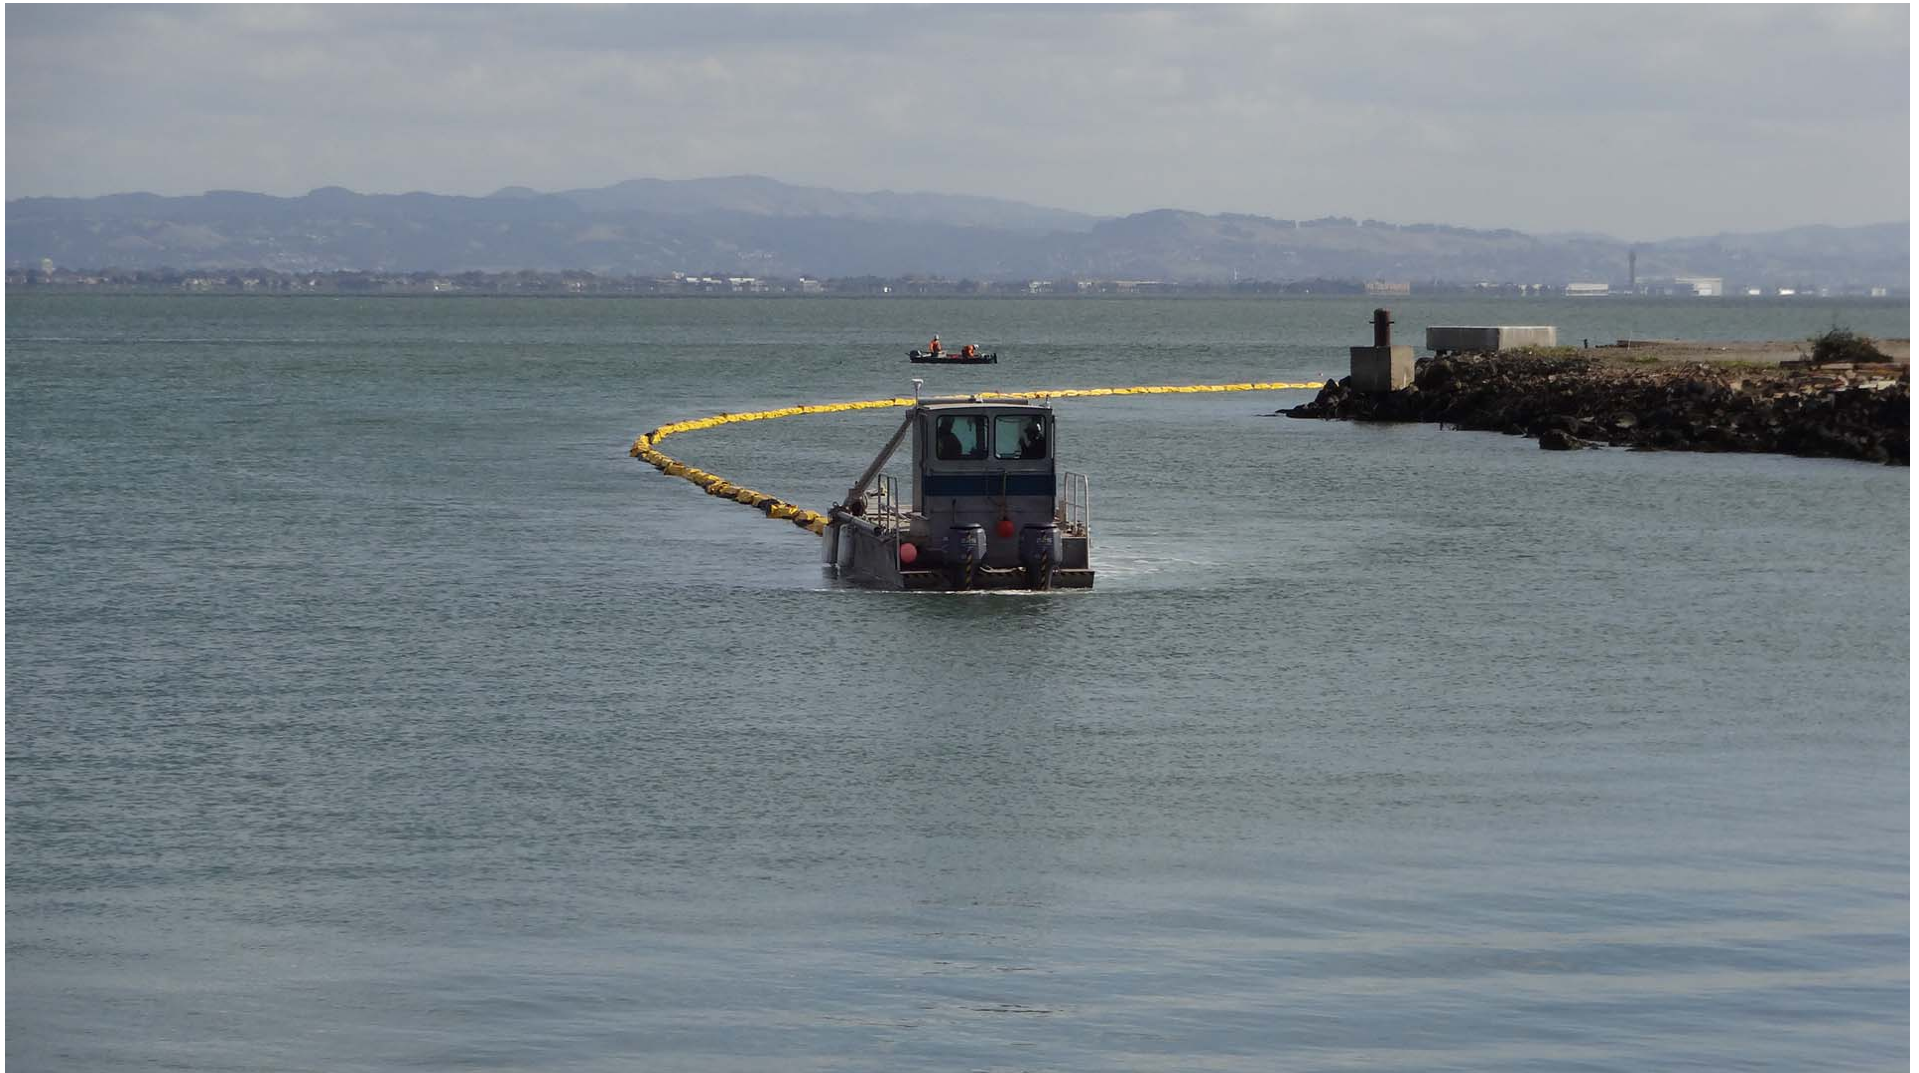
RA Photos Silt Curtain Deployment

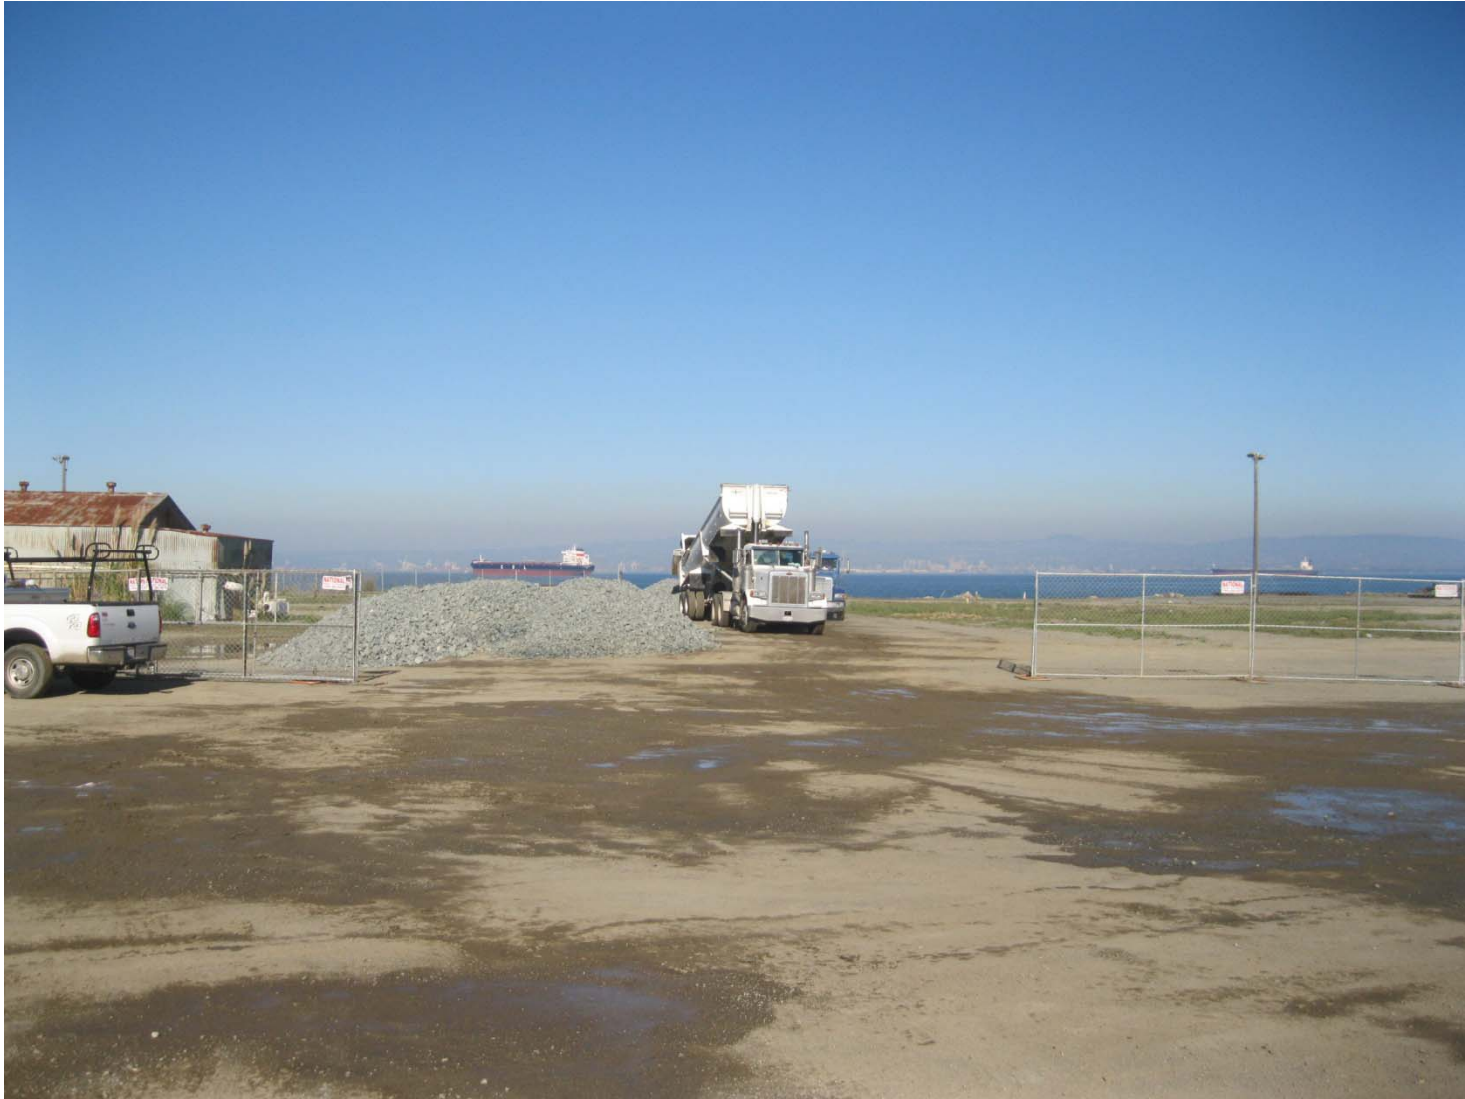
RA Photos Filter Rock Delivered by Truck

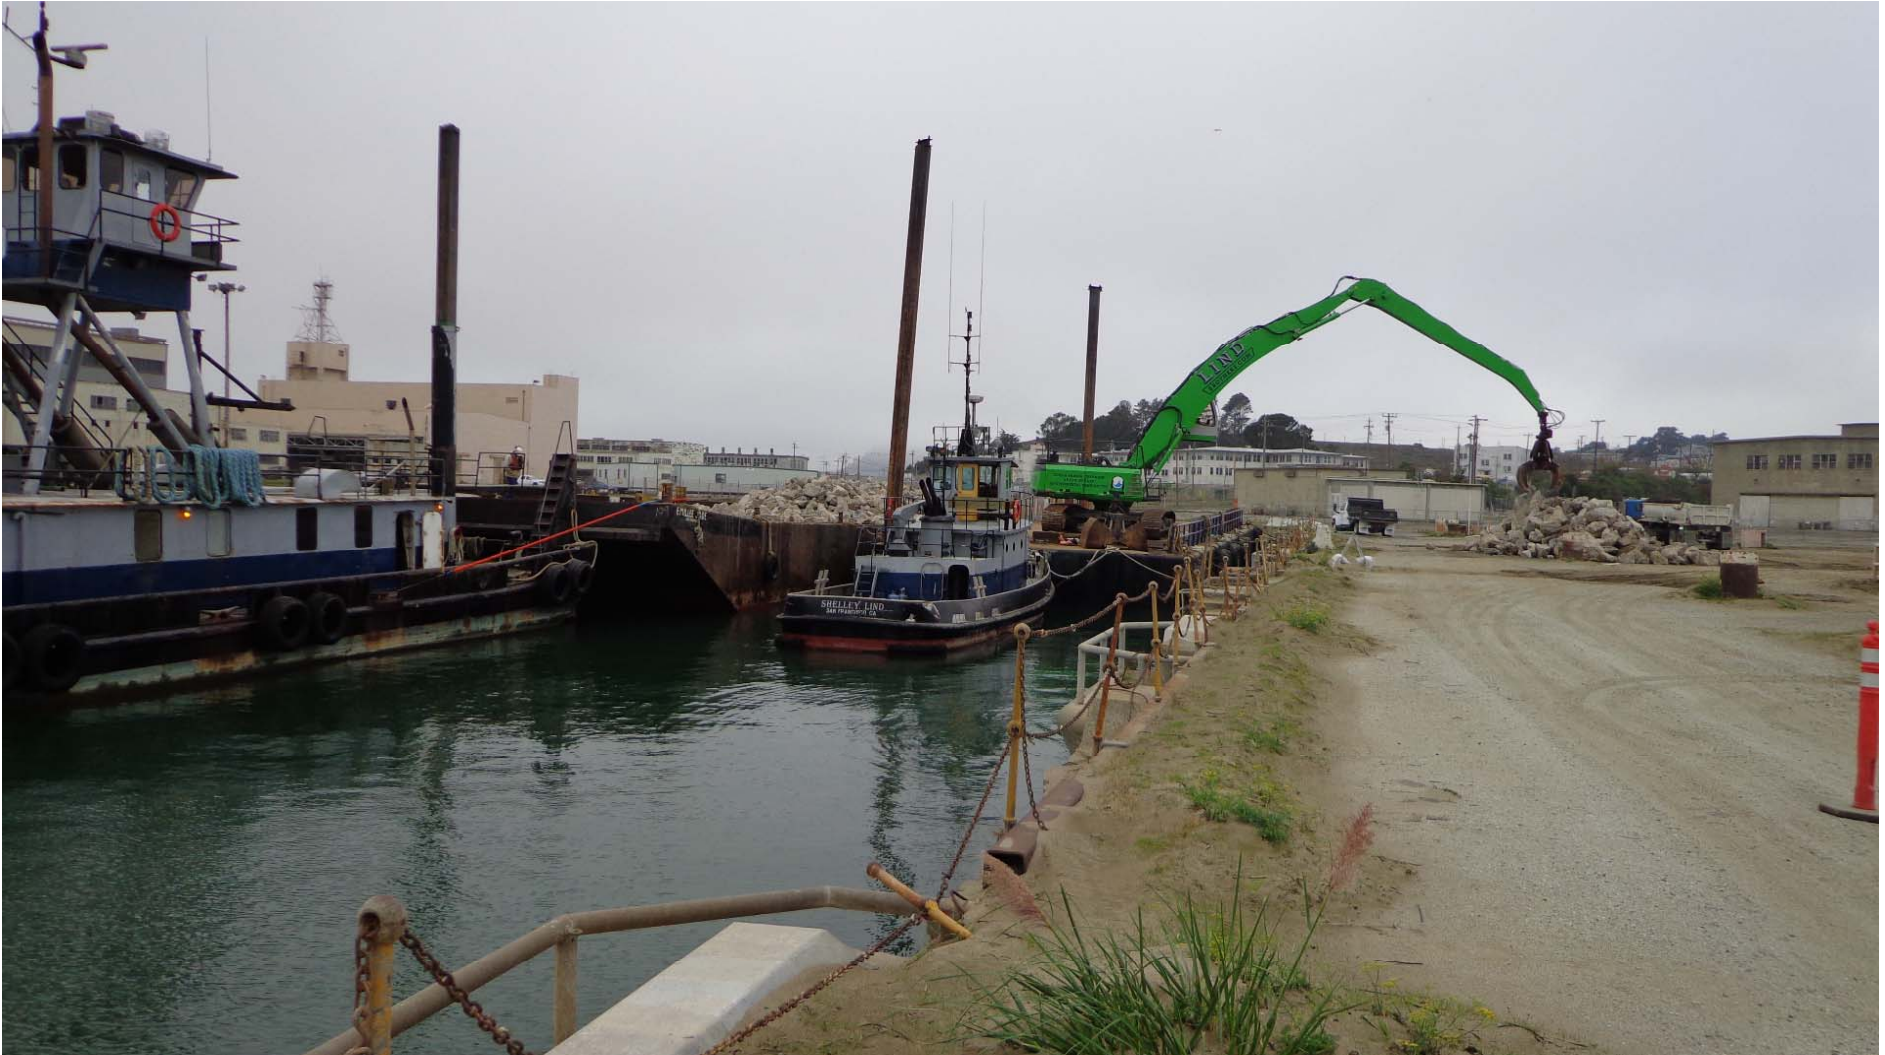
RA Photos Rip Rap Delivery by Barge

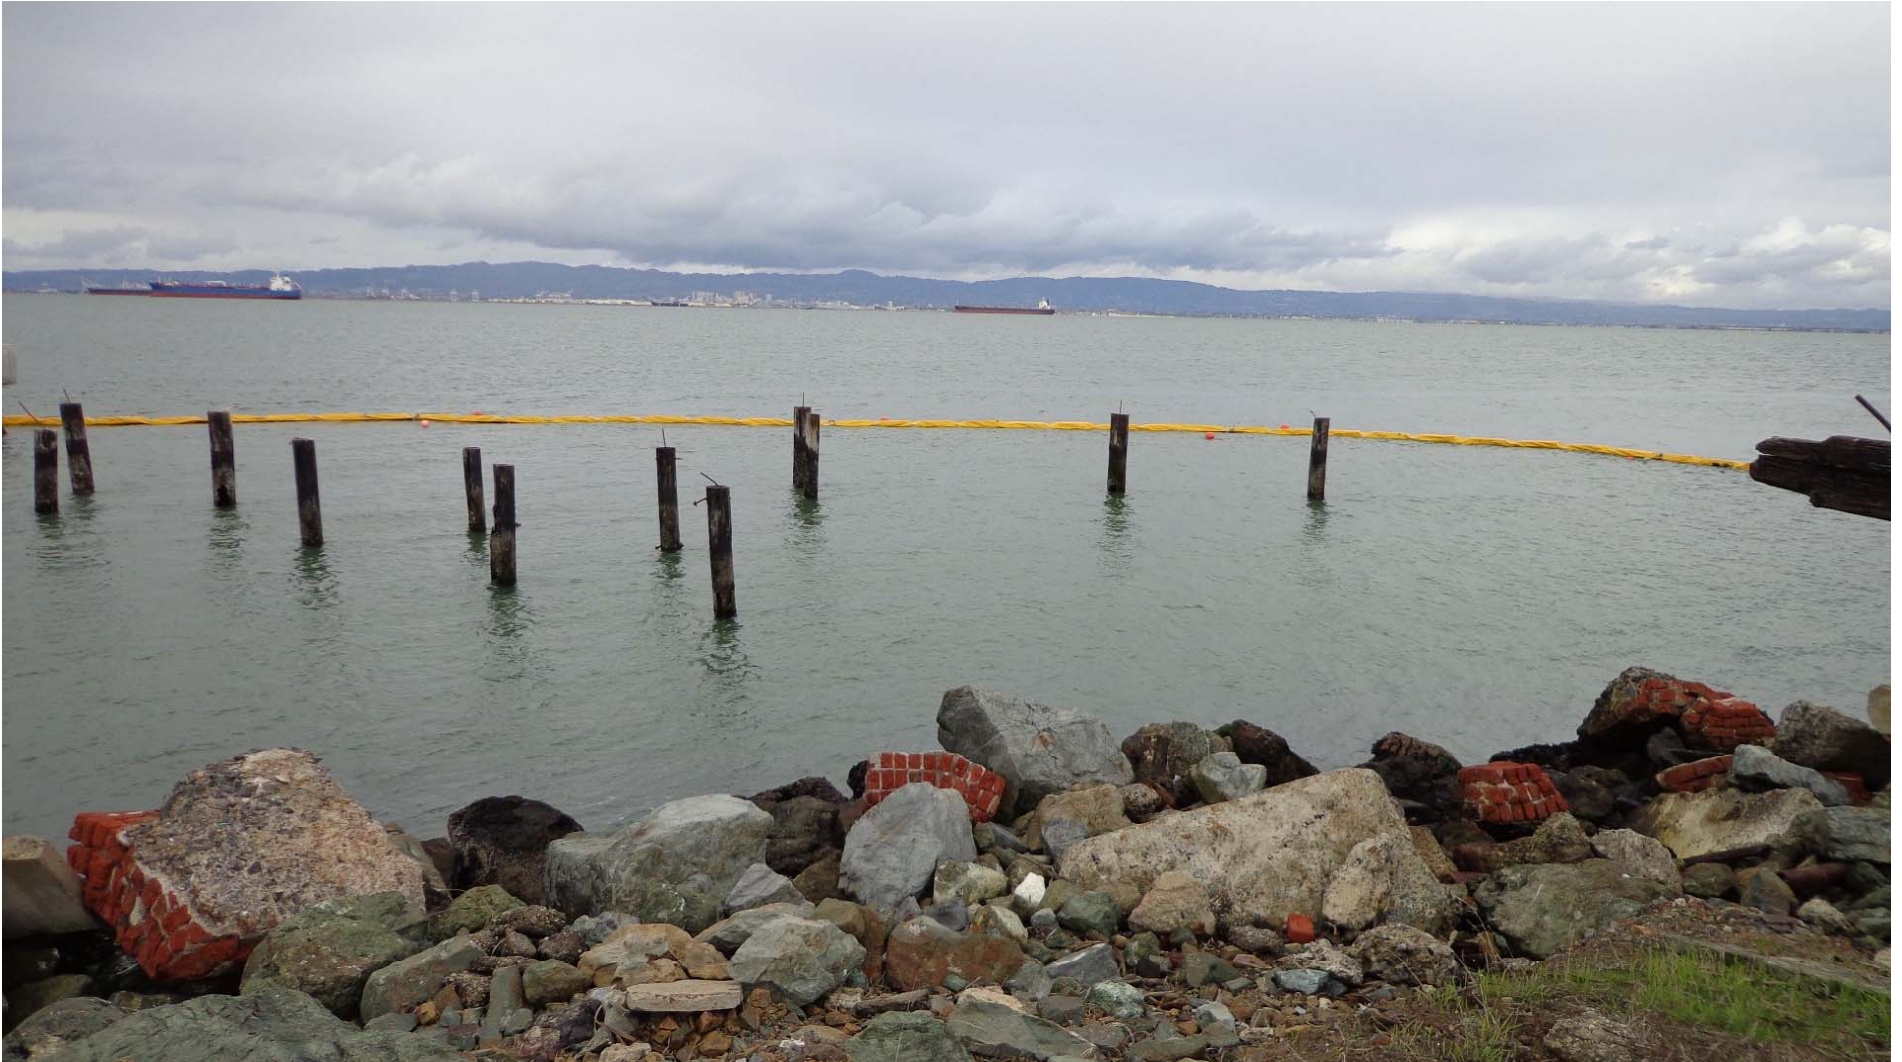
RA Photos Shoreline Debris

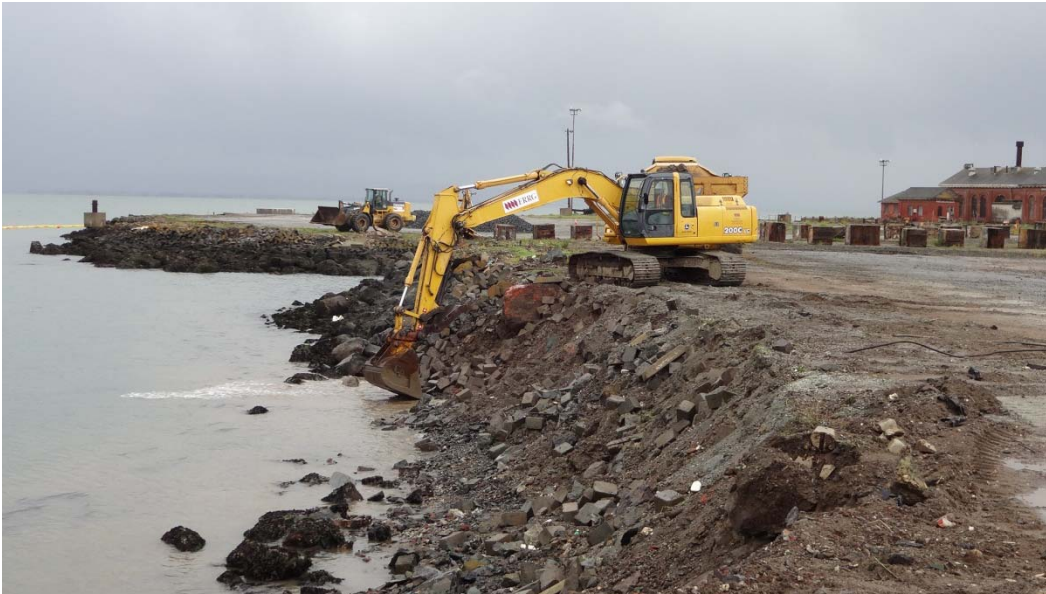
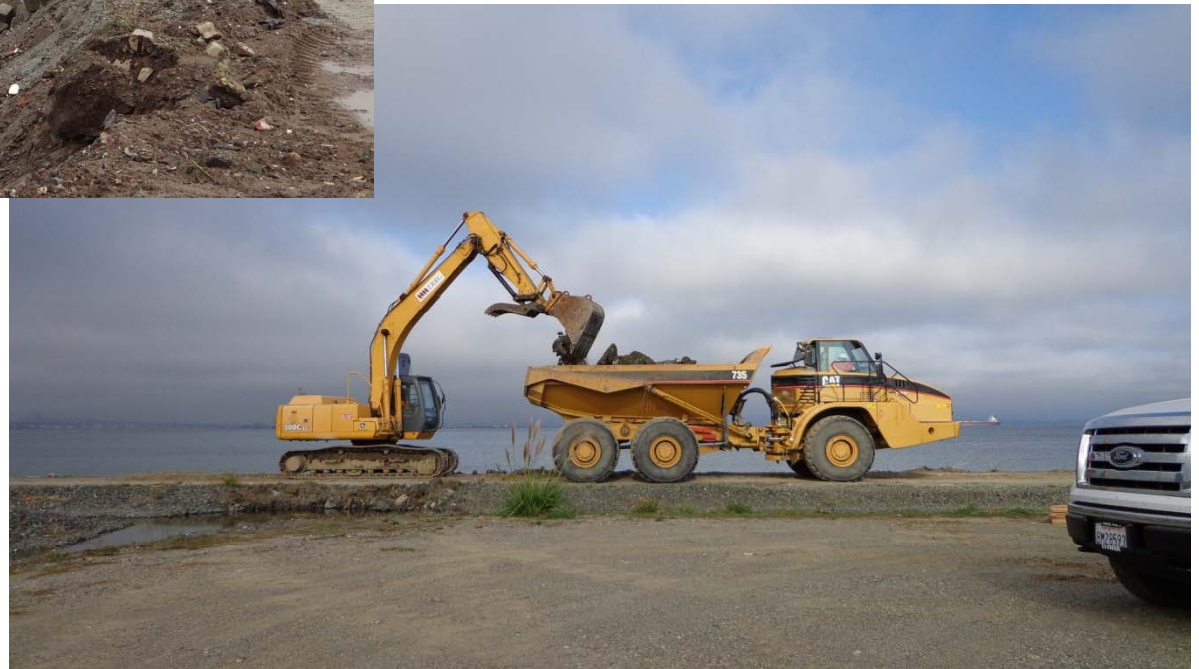
RA Photos Shoreline Debris Removal

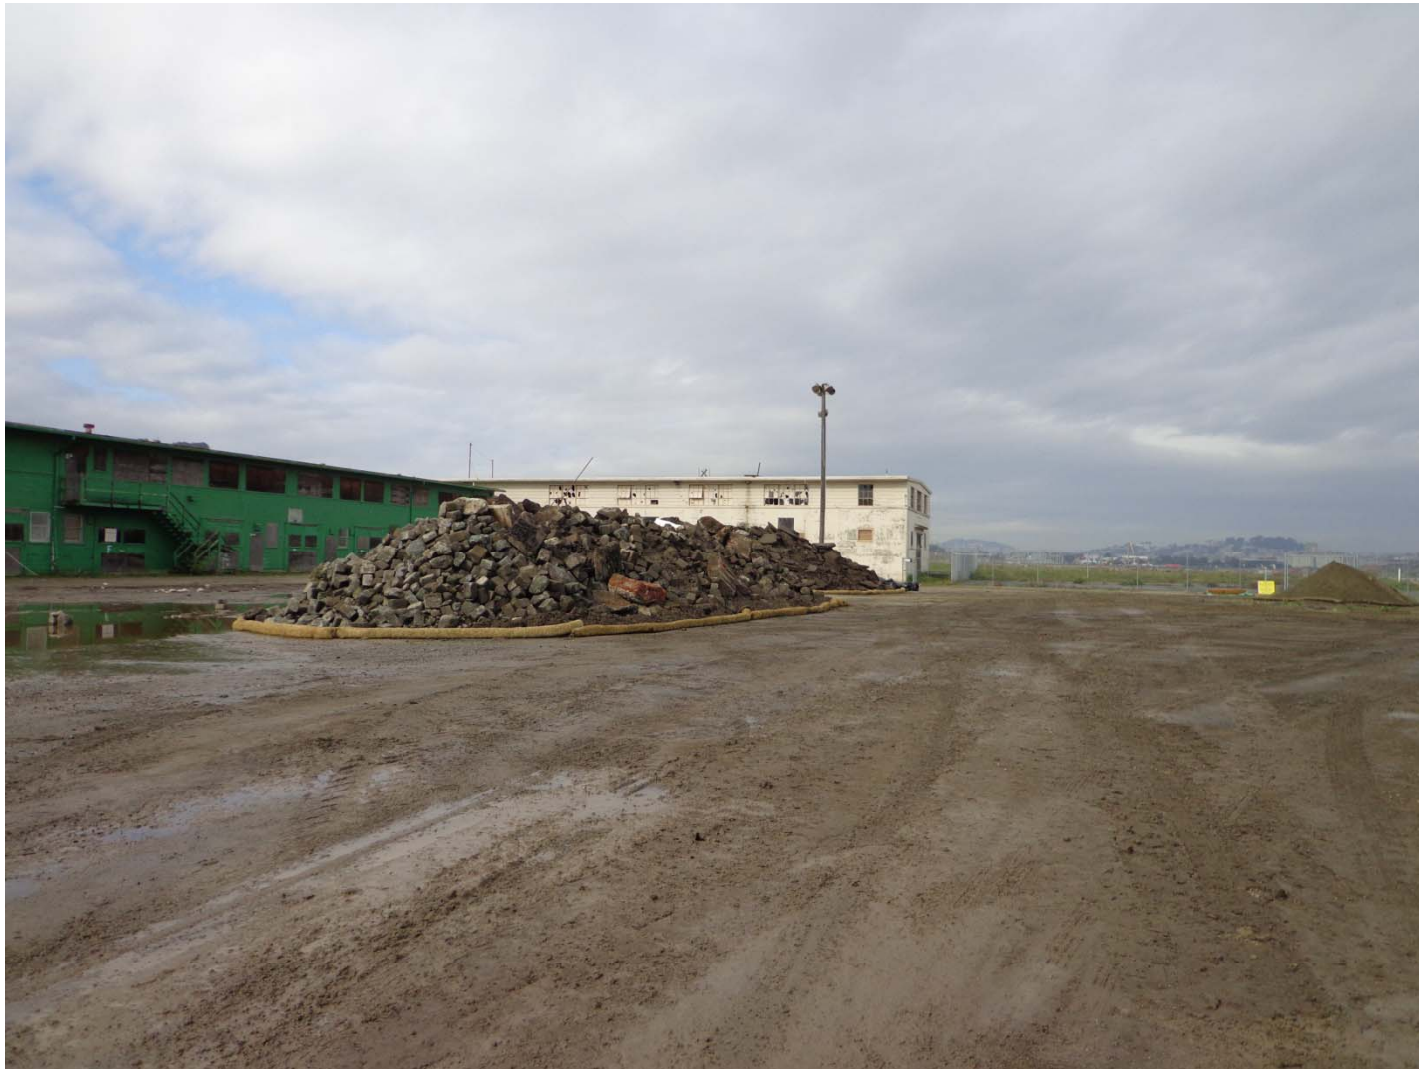
RA Photos Shoreline Debris Segregated and Stockpiled

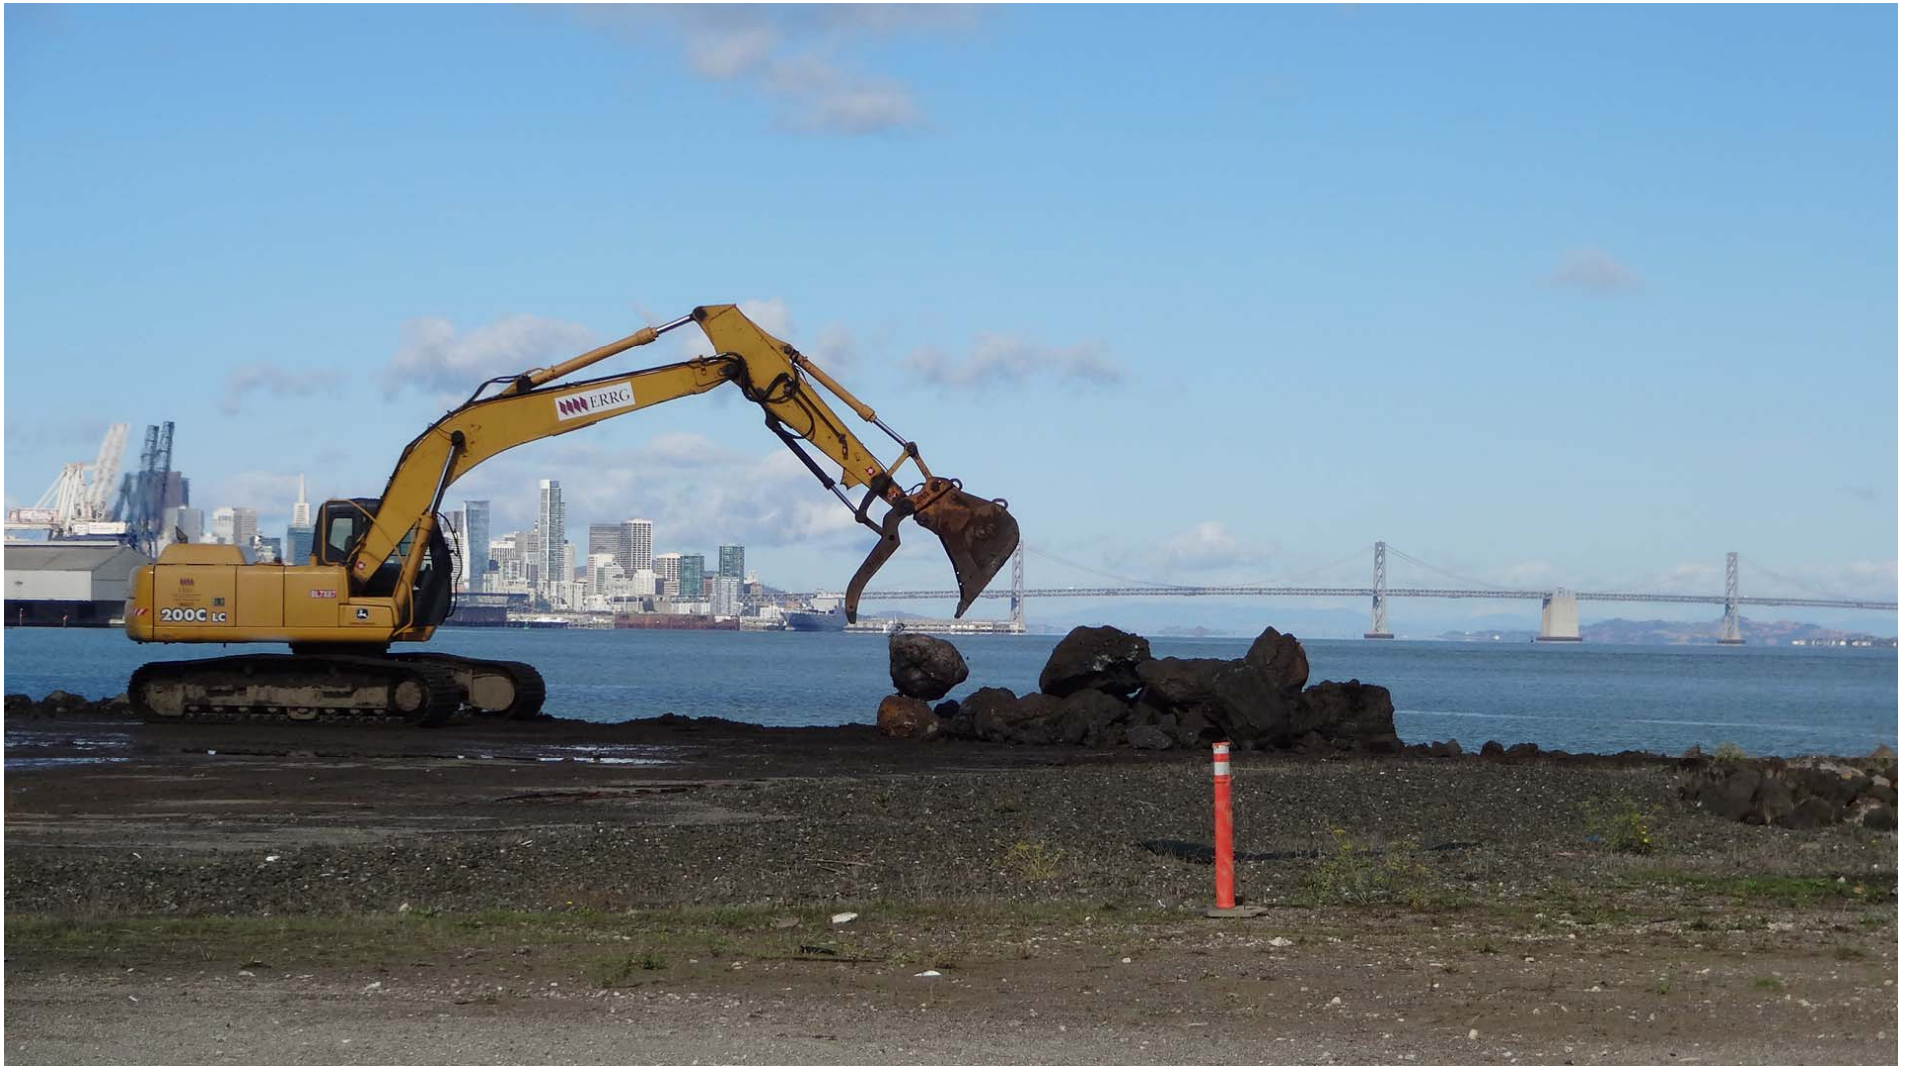
RA Photos Segregating Natural Rocks from Debris for Reuse

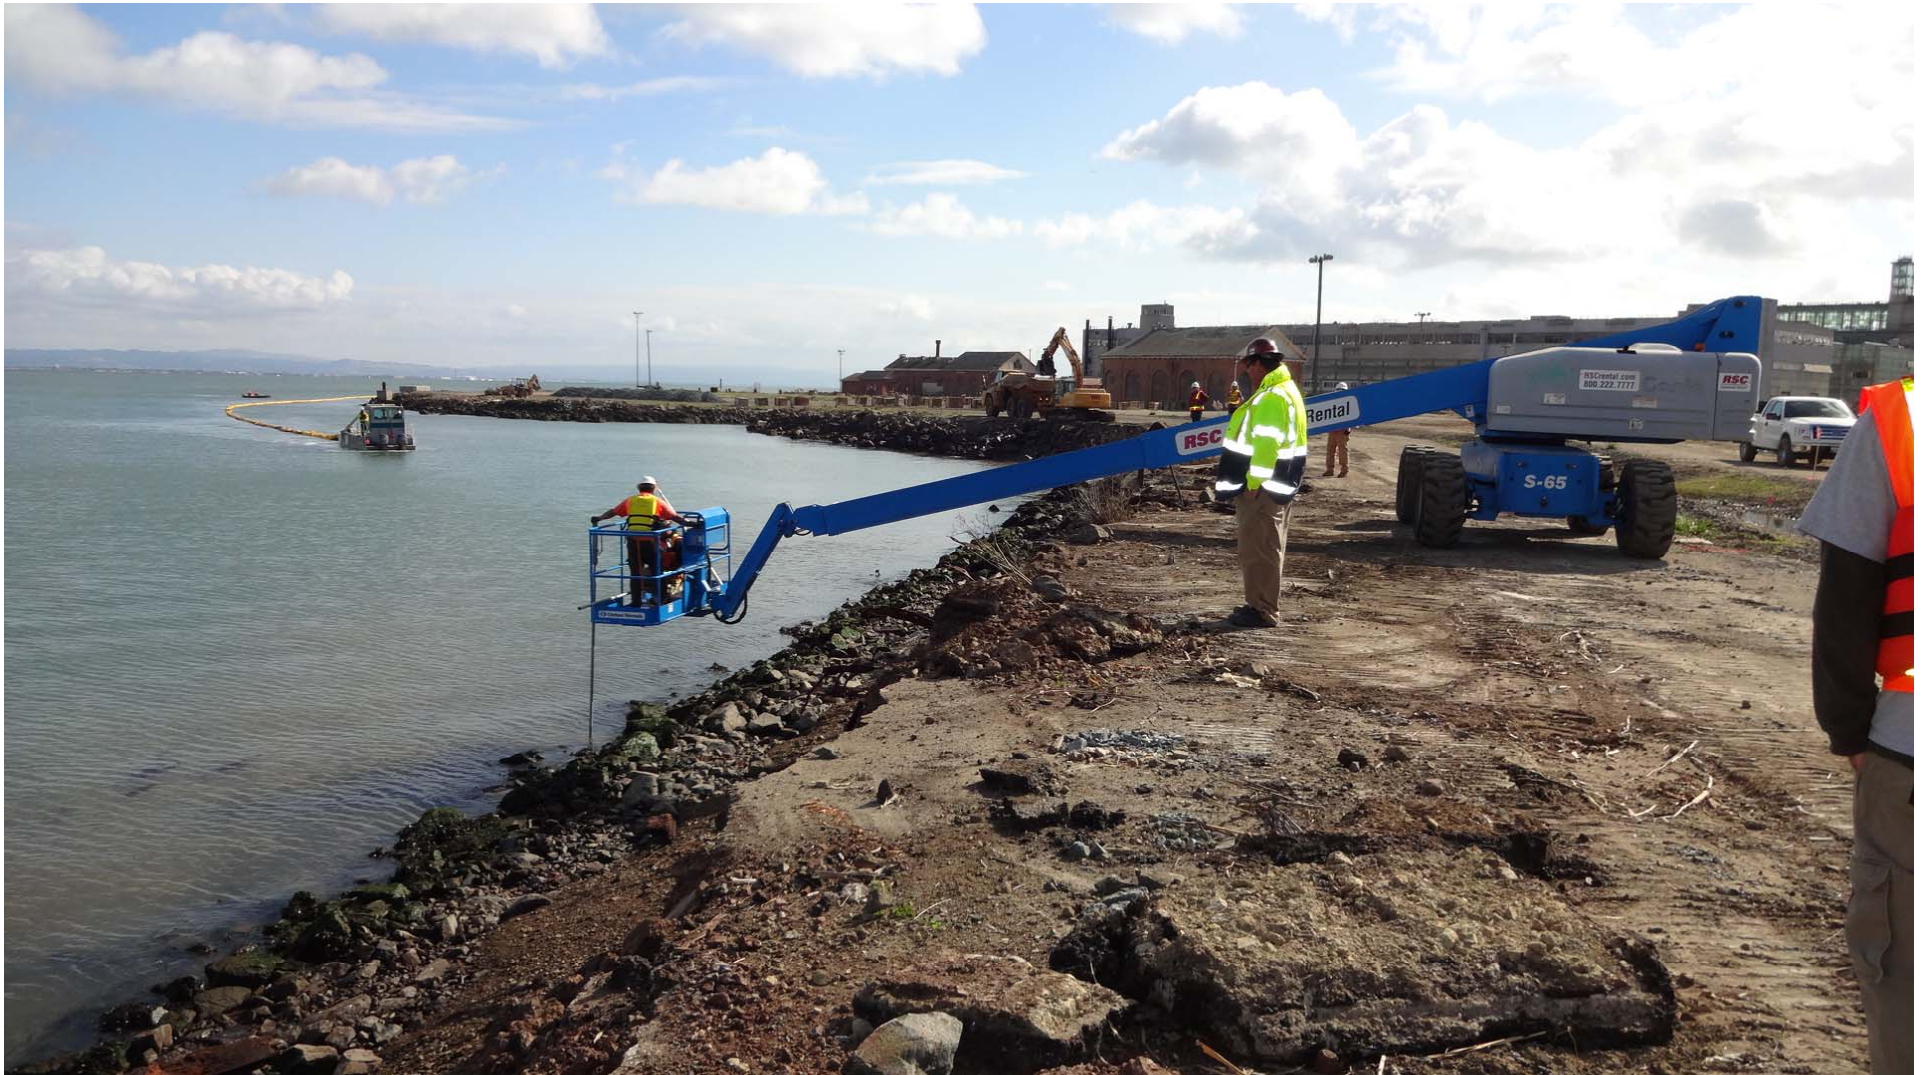
RA Photos Surveying the Shoreline

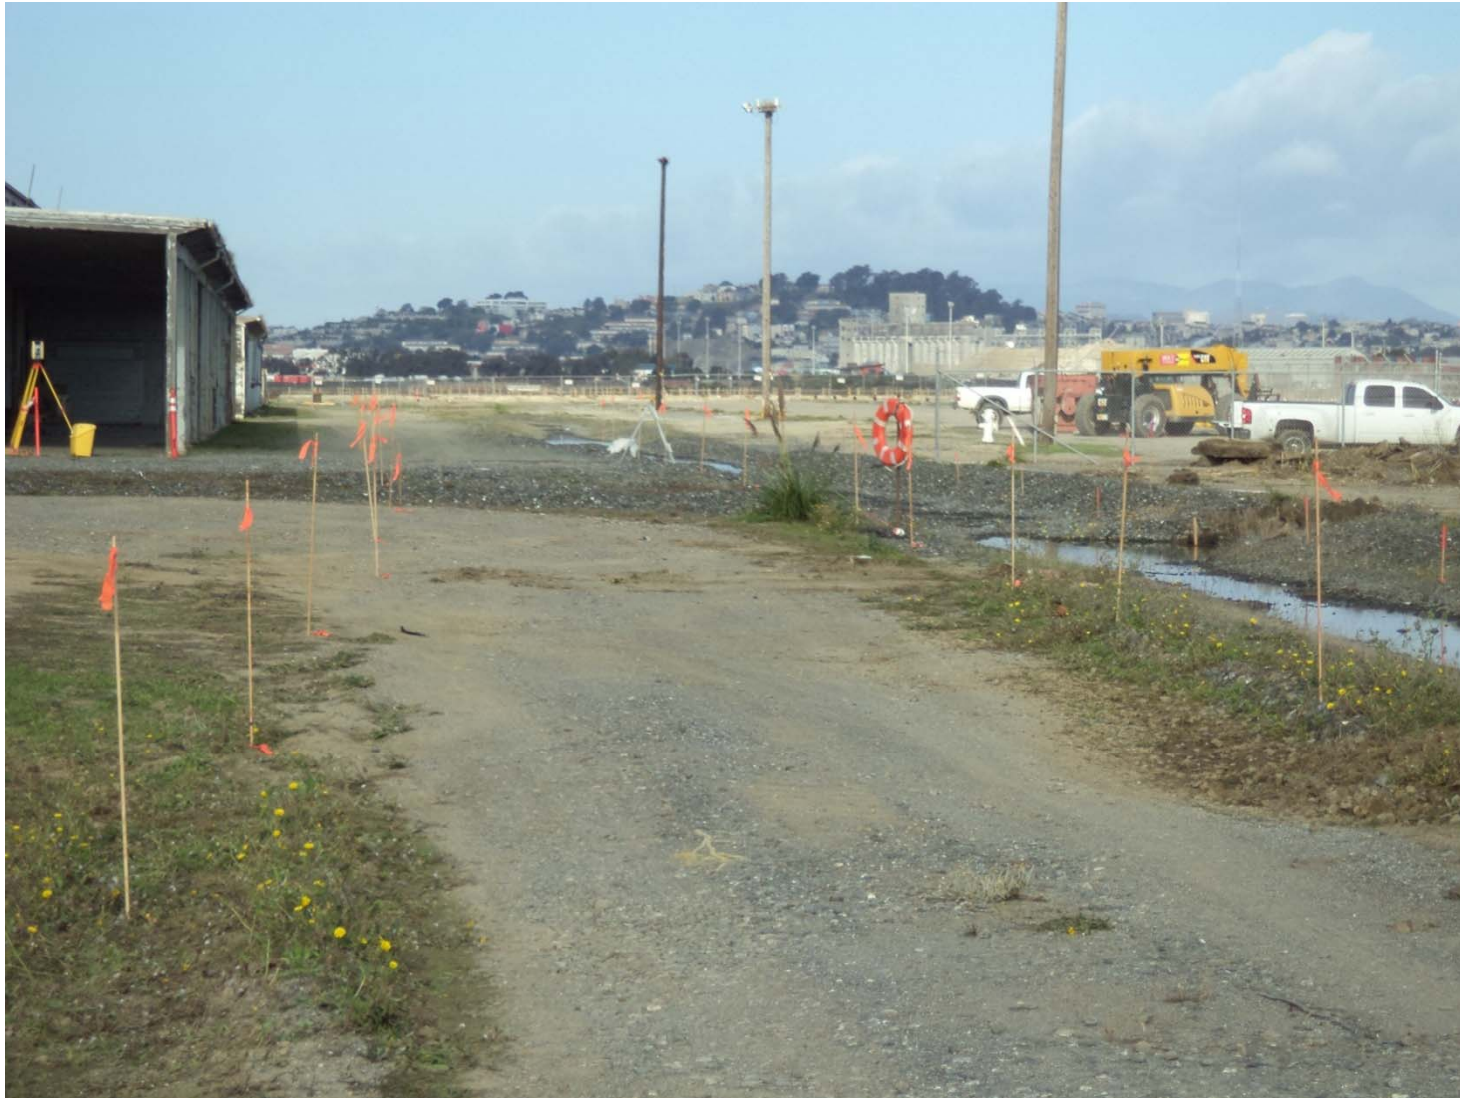
RA Photos Survey Stakes for Revetment Grade Checking

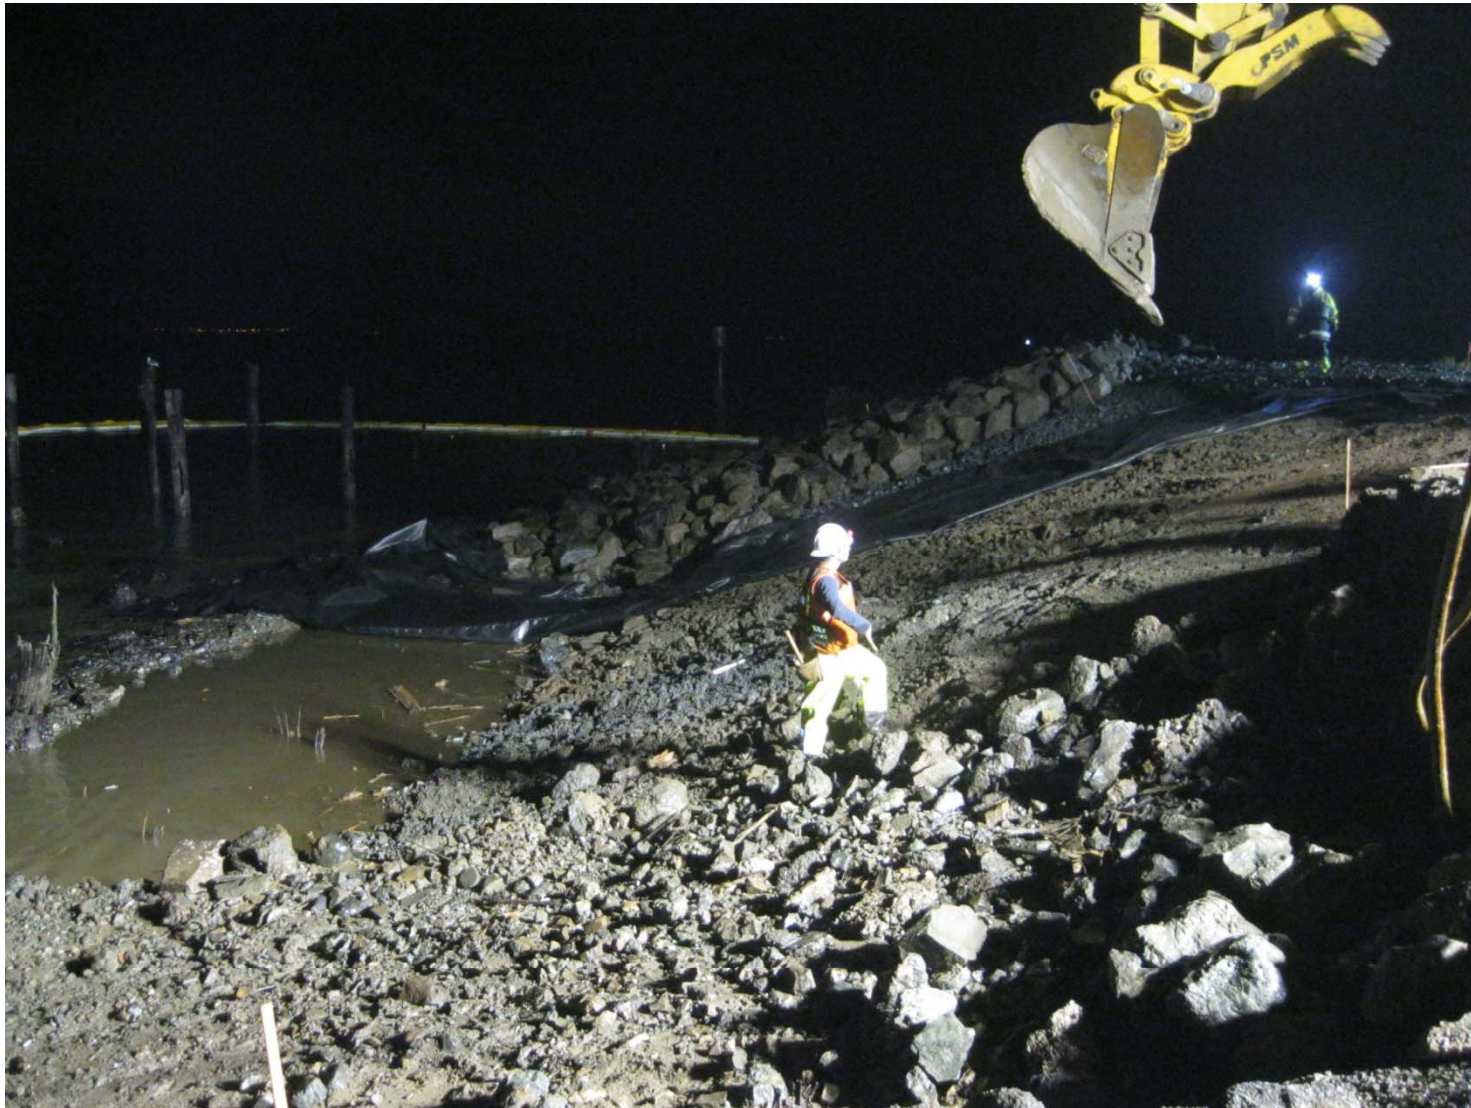
RA Photos Revetment Slope Excavation

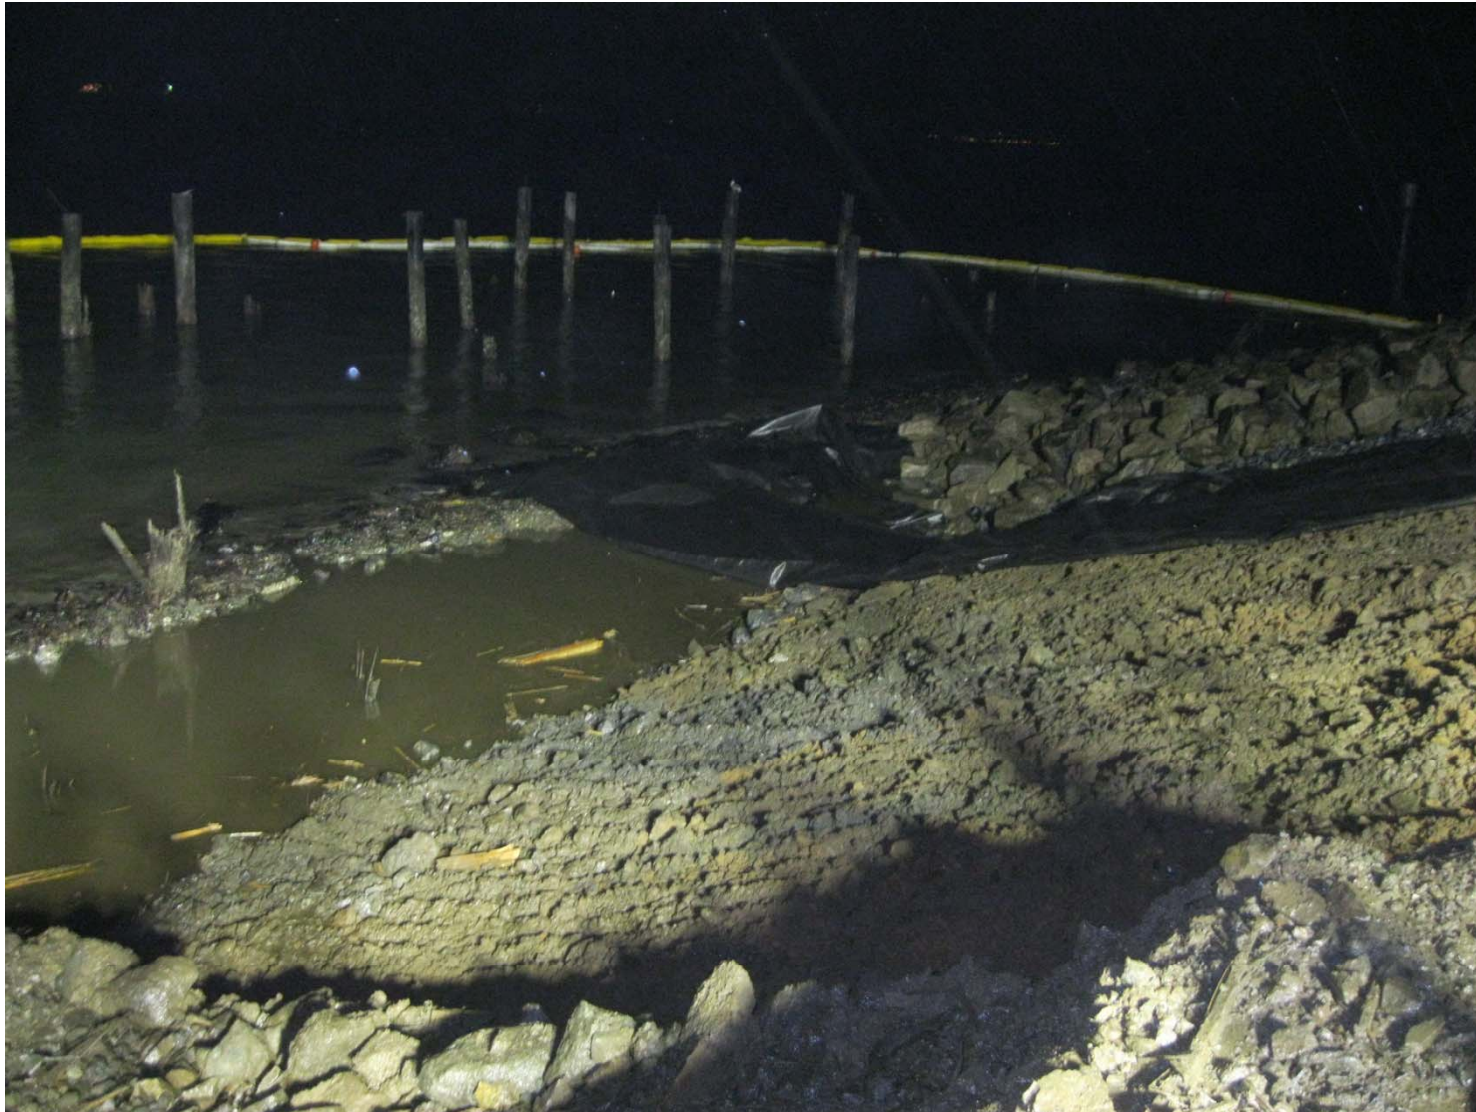
RA Photos Slope Prepared for Filter Fabric Placement
